SHERMAN LAKE DAM
BOLLINGER COUNTY, MISSOURI
MISSOURI INVENTORY NO. 30839

PHASE I INSPECTION REPORT
NATIONAL DAM SAFETY PROGRAM

PREPARED BY: ST. LOUIS DISTRICT CORPS OF ENGINEERS
FOR: GOVERNOR OF MISSOURI
AUGUST 1979

Name of Dam	Sherman Lake Dam
State Located	Missouri
County Located	Bollinger County
Stream	Castor River
Date of Inspection	23 May 1979

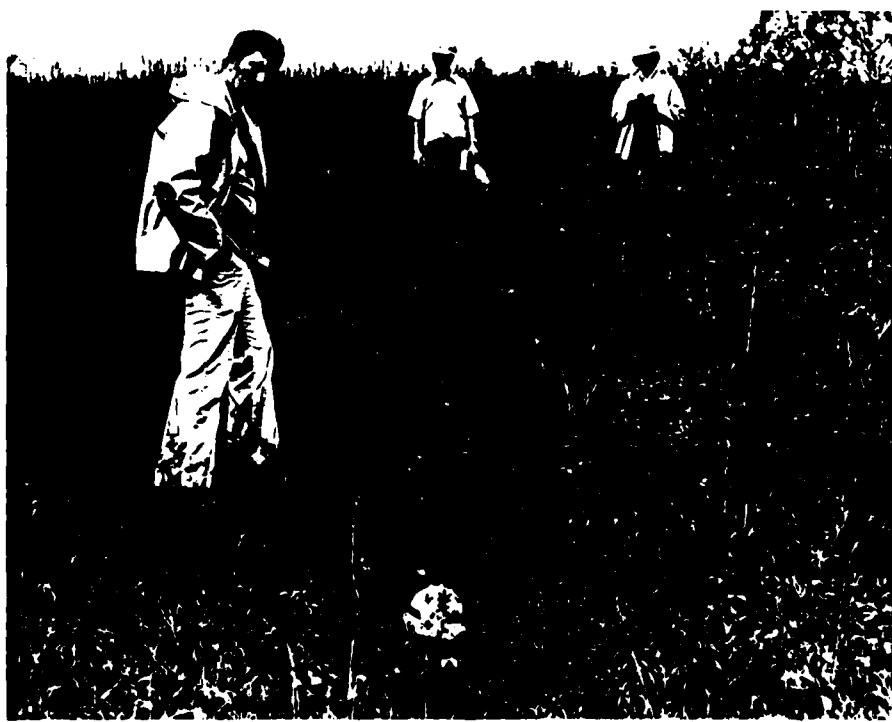
Trees and bushes are growing along the entire length of the upstream face of the dam (see Photo 4). The upstream embankment has no erosion protection and some wavewash and erosion has occurred intermittently along the upstream face (see Photo 5). Several erosion gullies were noted on the downstream side of the crown and on the downstream slopes at baseline stations 4+08 and 4+30 (see Photos 6 and 8). At station 5+35 there is a large wash area near the valley slope at the right abutment (see Photo 9).

PHOTO 8: Erosion on Downstream Slope

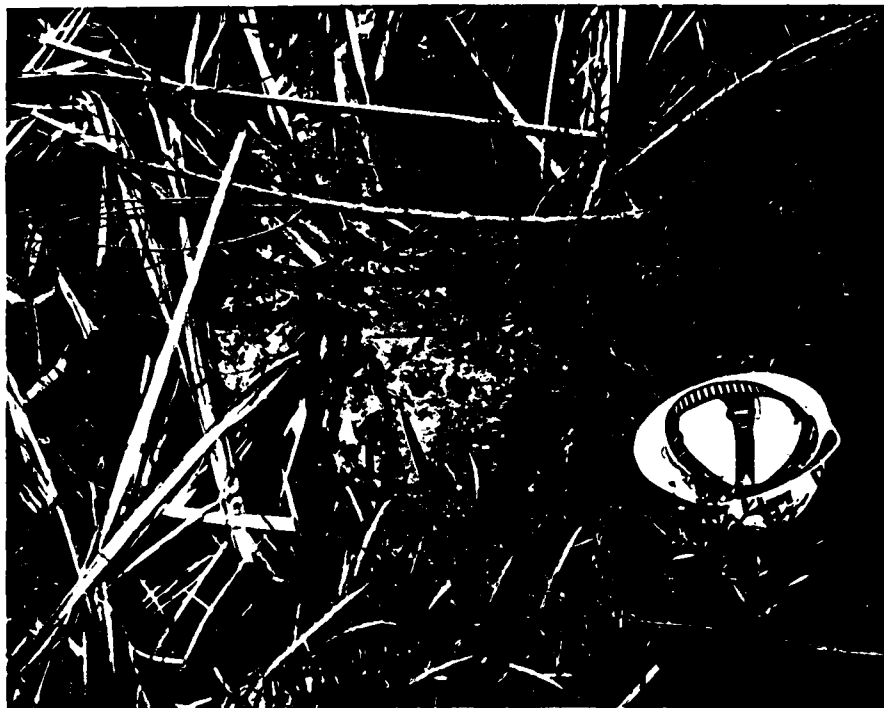
A large wet area was observed at the downstream toe of the dam from baseline 3+00⁺ to station 4+50⁺ (see Plate 6). The area was soft and spongy and was covered with trees, cattails, and other vegetation (see Photos 10 and 11). Crawfish holes were also observed in the area. Portions of the area appeared to be just trapped water, but evidence of seepage was apparent at several locations (see Photos 12 and 13). The majority of the seepage seemed to be concentrated in an area from stations 4+00 to 4+50. Seepage flows were estimated to be 50 gpm. No material was observed being piped by the seepage flows.

PHOTO 13: Seepage at Downstream Toe

b. Perform seepage and stability analyses to assess the safety concerns raised by the seepage present at the downstream toe of the dam. Use the results of these analyses to design appropriate corrective measures.
